SUMMARY REPORT

Inspection Address: 609 Northern Ave, Mill Valley, CA 94941
Inspection Date: 1/3/2007 Start: 1:00 pm End: 2:30 pm

Inspected by: Peter Nusser

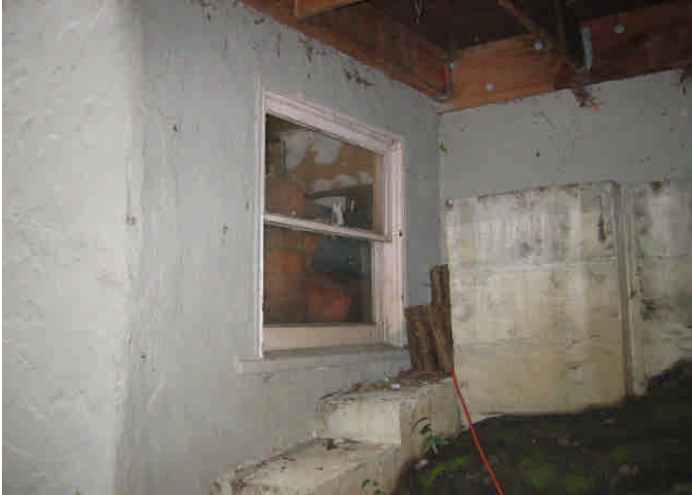
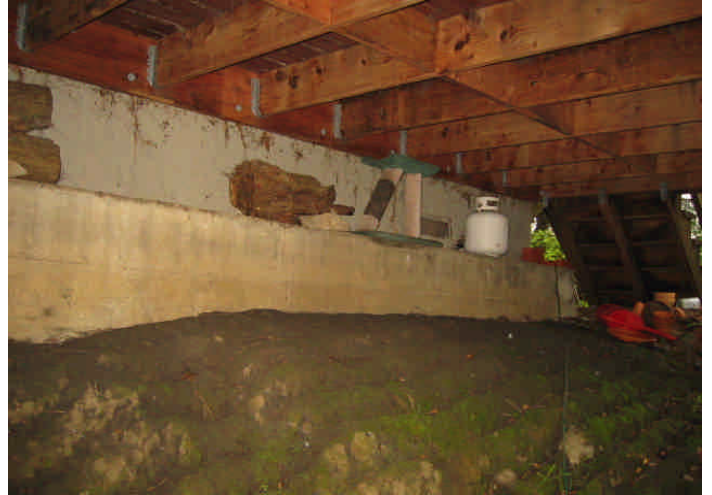
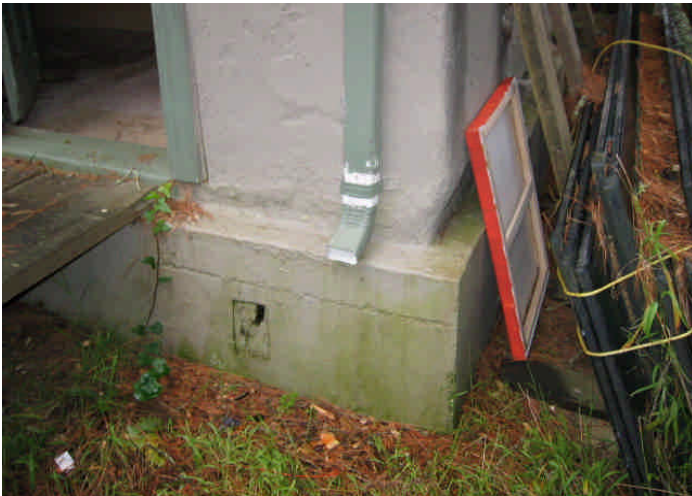
- 1.1 - There is evidence that the foundation walls have been braced or repaired at several areas around the home. There are several inches of additional concrete at the exterior of the foundation walls. Therefore, you should request the engineering report documentation from the sellers and who did the work which may include warranties or guarantees that might be applicable. We do not approve of, or tacitly endorse, any work done without permits and by unlicensed contractors as latent defects could exist. If there is no documentation, then you should have structural engineer or geo-technical engineer

evaluate to determine the appropriate course of action, because this may affect your evaluation of the property.

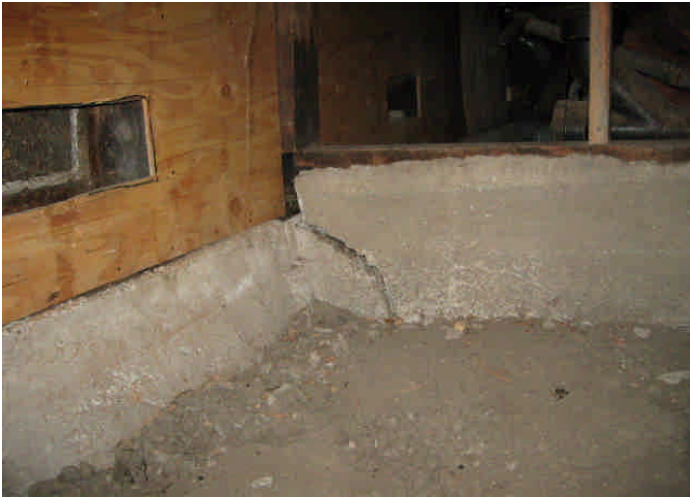
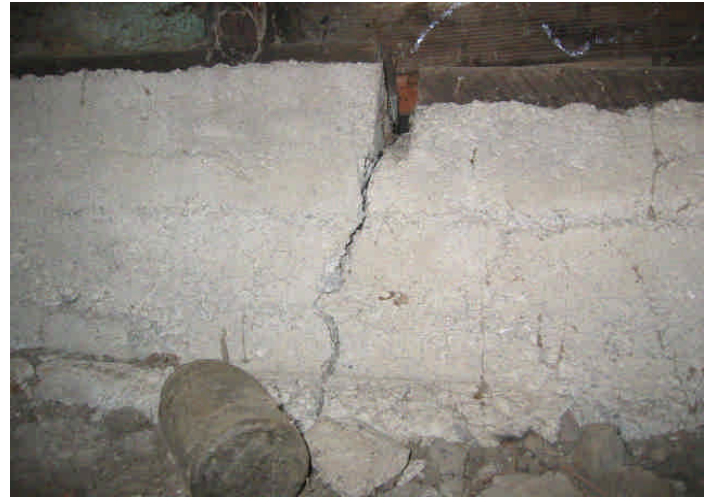
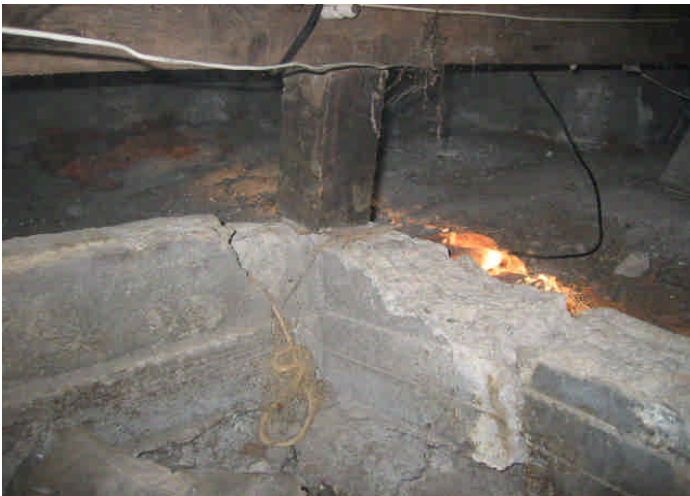
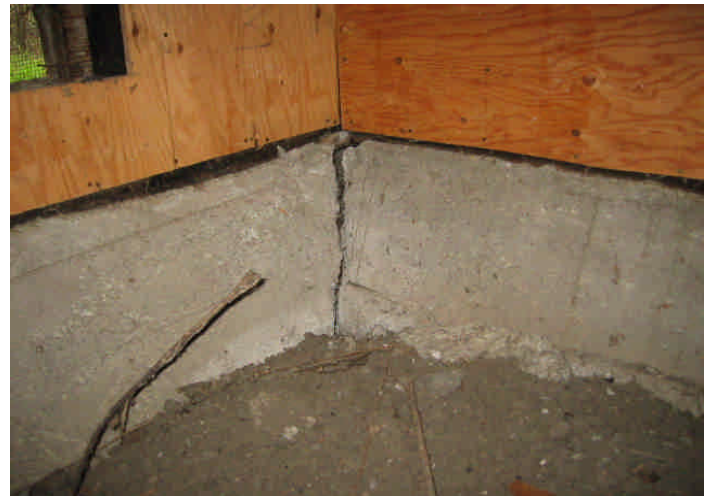
- 1.2 - The foundation walls are cracked in several locations and movement has occurred. Because of the age of the foundation, the adjacent creek and the home is on a hillside, it is recommended that you have a second opinion on the stability of the land. Please review the foundation exterior comments in this report.

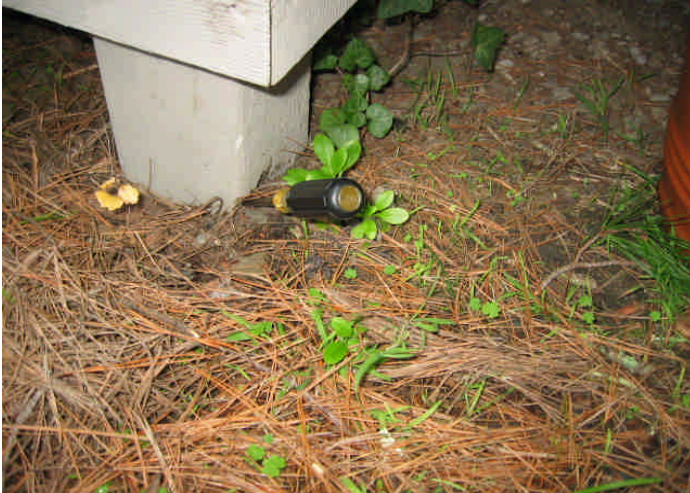
The post at the front of the home, at the kitchen area is moisture damaged at its bases, which should be commented on by the pest inspector.

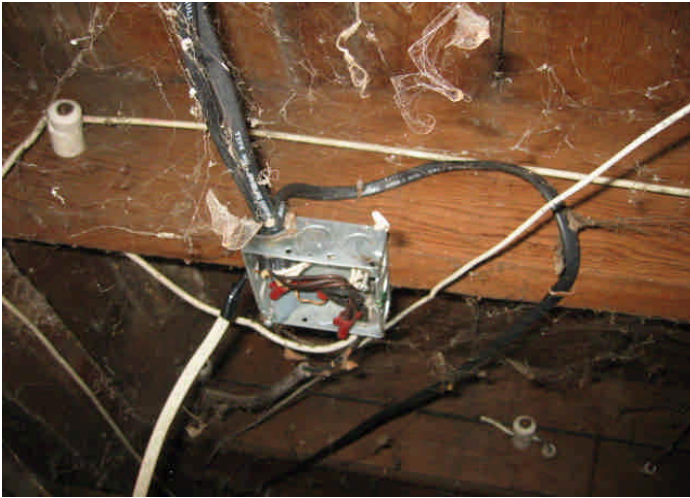
[Health & Safety] There is an open electrical junction box within the crawlspace, which should be sealed so that any arcing or sparking would be contained within the box. Indicating a homeowner type installation. This is a potentially unsafe condition.

Recommend further evaluation by an electrician.

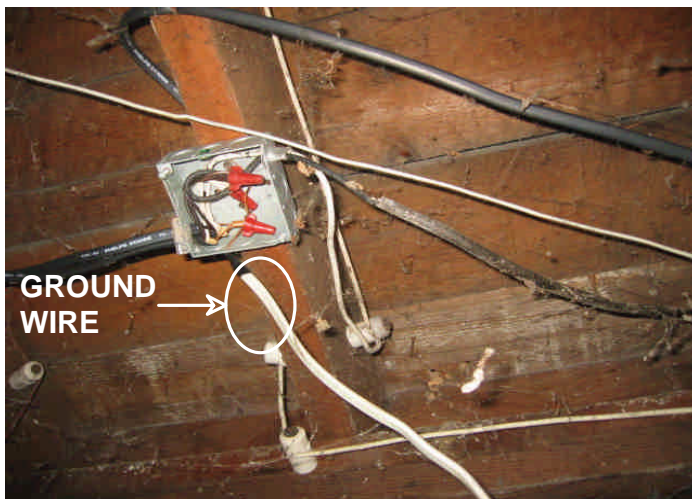
[Health & Safety] The neutral wires in the crawlspace have been incorrectly connected to the ground rod. Indicating a homeowner/occupant type installation, which is a potentially unsafe condition. Recommend further evaluation and repairs by an electrician.

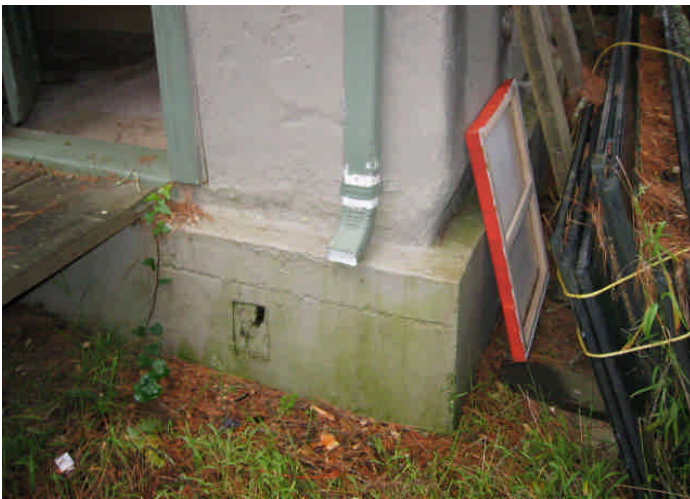
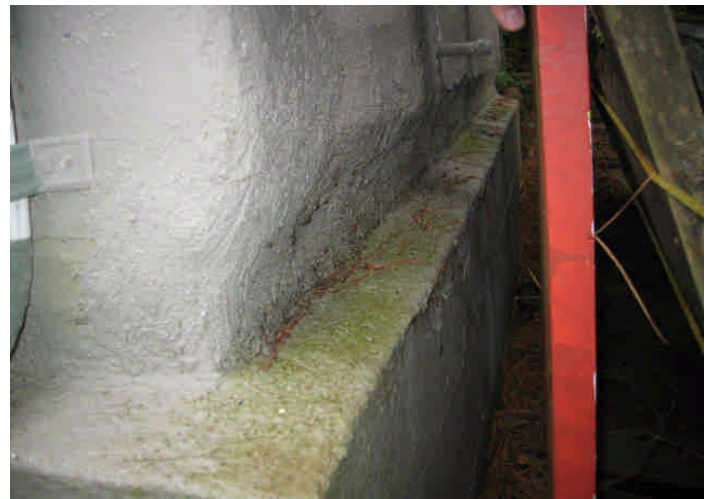
The stucco extends down to the soil without the benefit of a weep-screed, which allows the house walls to move independent of the foundation, and not only prevent the plate-line cracks that are commonly seen at the base of many stuccoed walls but isolates the stucco from the soil and inhibits the wicking effect of moisture being drawn up into the stucco that, in turn, creates the flaking and peeling that is common on such surfaces.

There is a bulge in the stucco wall adjacent to the laundry area. It should also be noted that the floor in the bedroom above is sloped in this area. Please review the comments in the raised foundation section of this report.

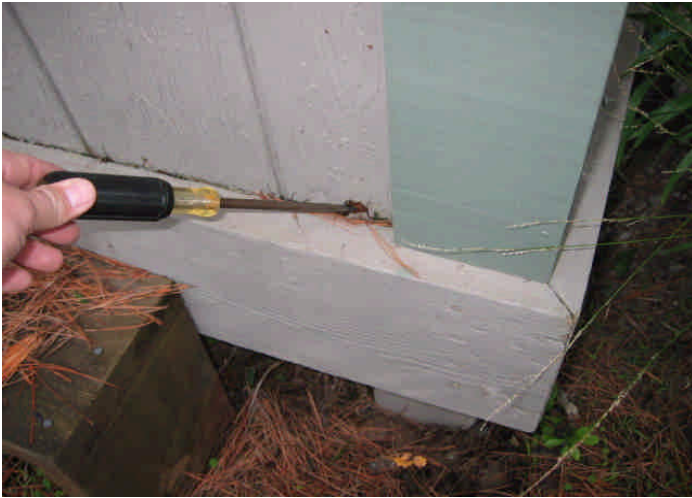
The wood siding is deteriorated in several areas around the home, possibly due to the age of the siding or sprinklers over spraying or the gutters overflowing which should be serviced. Please review the pest inspection report on the exterior for full details.

Recommend further evaluation by a pest inspector and/or a siding contractor.

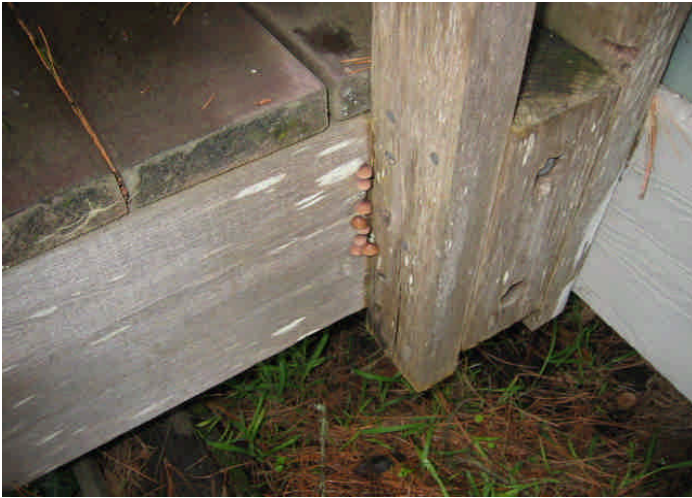
The entryway porch deck has fungus on it, which should be further evaluated by a general contractor/per inspector. Please review the pest report for additional information.

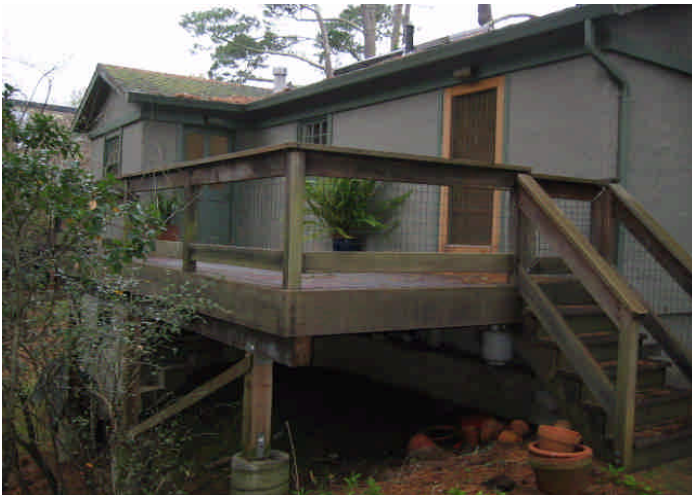
The screen in the deck rails is climbable which may not be child safe. Modern safety standards require the hand rail to be a minimum of thirty-two inches high with no more than a four-inch space between the pickets. This may have been the building standard at the time the deck was built. If this house was built today, the building standards would require less than four inch spaces between the pickets. Therefore, you may wish to add a non climbable protective barrier.

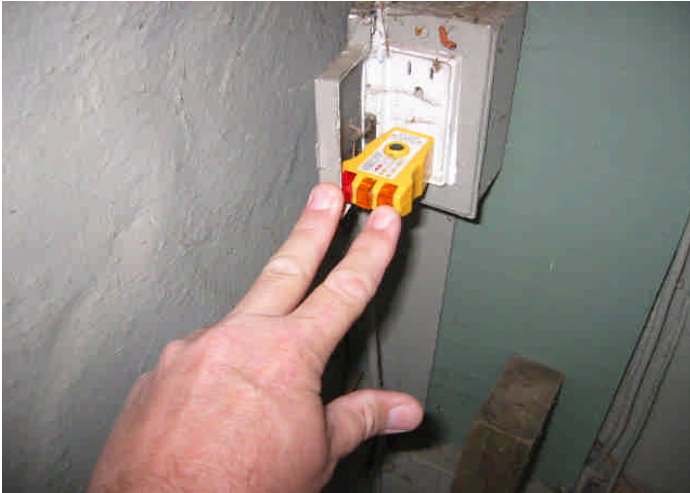
[Health & Safety] A ground-fault protected outlet in the side yard does not trip on test, and should be serviced. Recommend further evaluation by an electrical contractor.

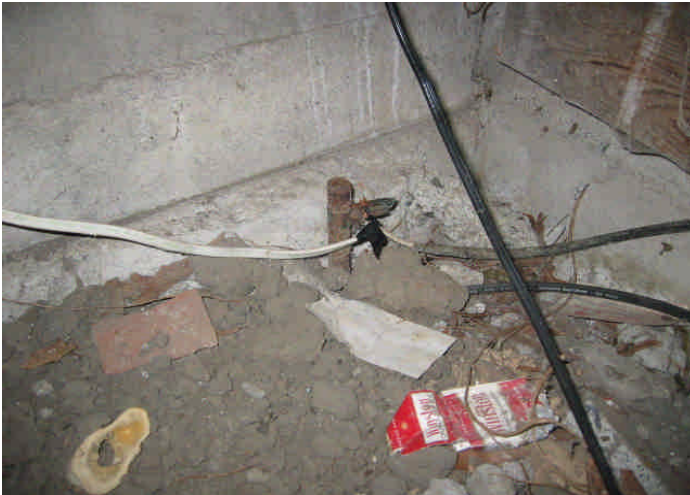
[Health & Safety] The main electrical panel ground wire is the wrong type of wire. The ground wire should be a minimum eight gauge bare copper wire. The ground wire was not connected to the driven rod with the appropriate clamp. Also, due to the location the ground rod may not have been driven into the ground eight feet.

Recommend an electrician evaluate and repair this.

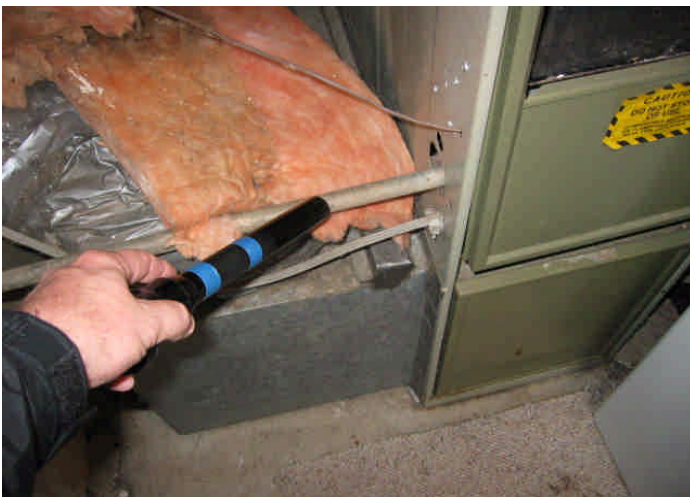
[Health & Safety] There is no gas shut-off valve and no flexible connection at the feed line to the furnace, which is required by modern building standards.

Recommend further evaluation by an HVAC contractor.

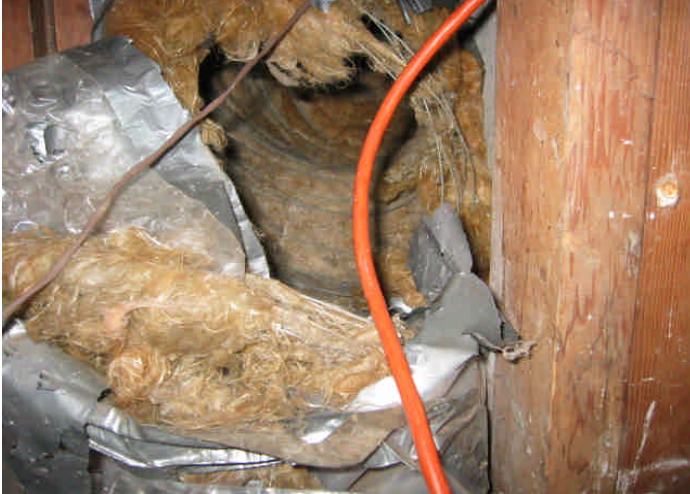
The return-air duct in the basement is damaged, crushed and has a hole in it, which should be replaced. Recommend further evaluation by an HVAC contractor.

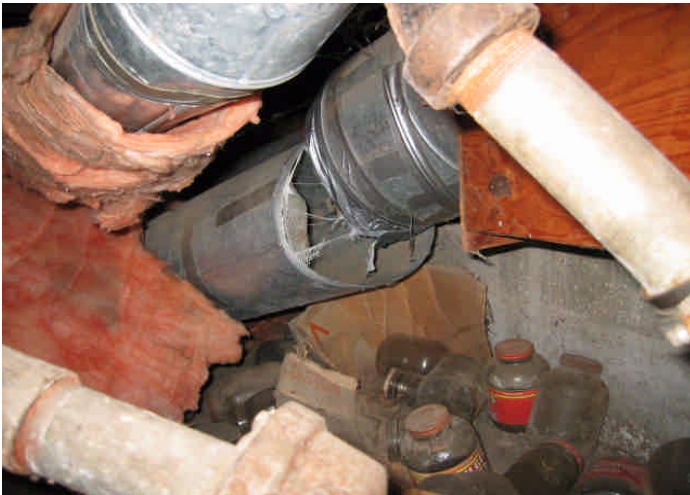
One of the ducts in the crawlspace has separated, which should be reconnected and secured.

Recommend an HVAC contractor further evaluate.

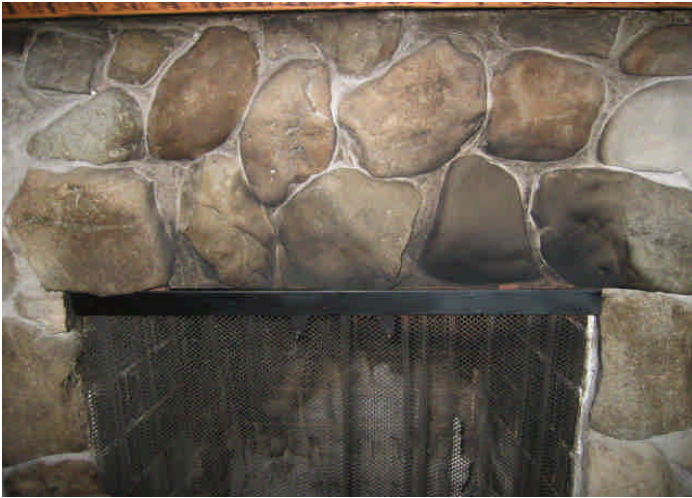
There are carbon deposits or scorch marks around the fireplace, which suggest that the chimney does not draft well or the damper was closed when a fire was lit. If the fireplace is not drafting properly, this will cause carbon monoxide to enter the home. You should ask the sellers if they have ever had drafting problems, or you may wish to have a fireplace contractor evaluate and comment on this.

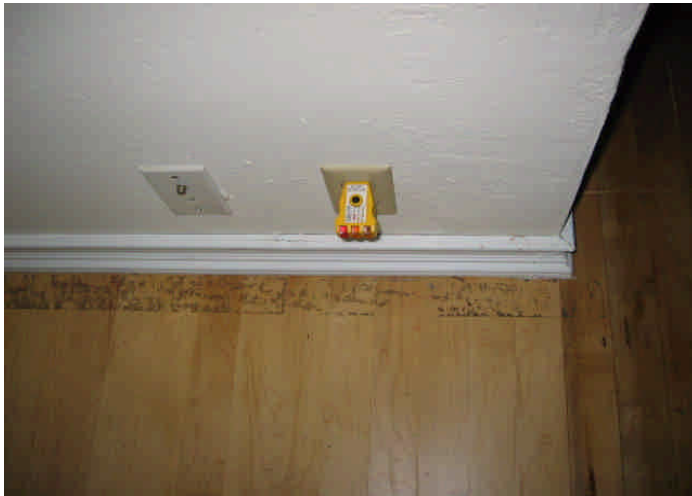
[Health & Safety] An outlet has reversed polarity, and should be serviced by an electrician. Recommend further evaluation by an electrician.

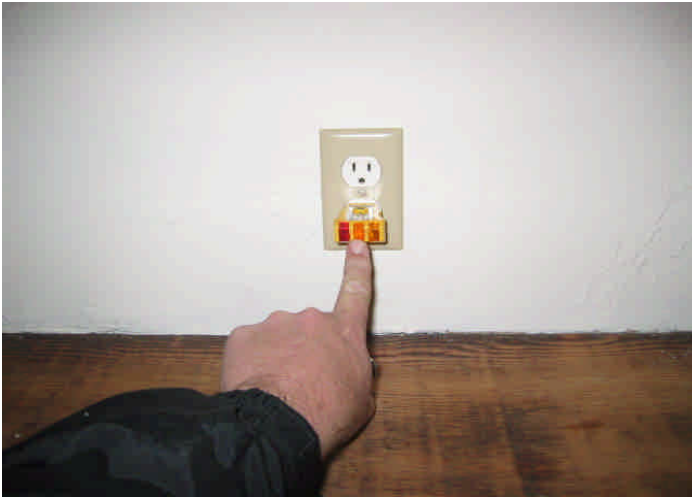
[Health & Safety] An outlet has an open ground, and should be serviced by an electrician.

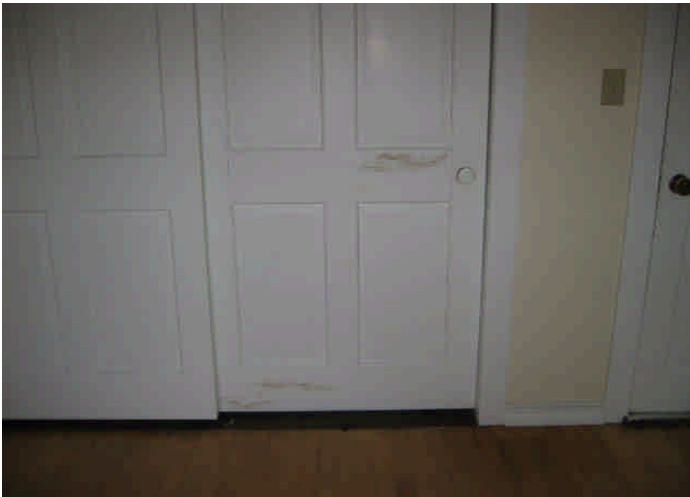
The closet doors are rubbing against each other, which is damaging the paint. Recommend servicing the doors and checking their operation.

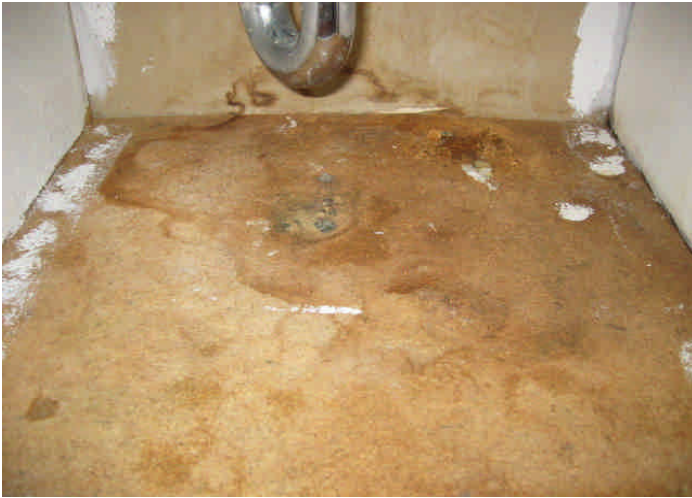
The floor of the sink cabinet is functional but moisture stained, which you may wish to see for yourself. Please review the pest report.

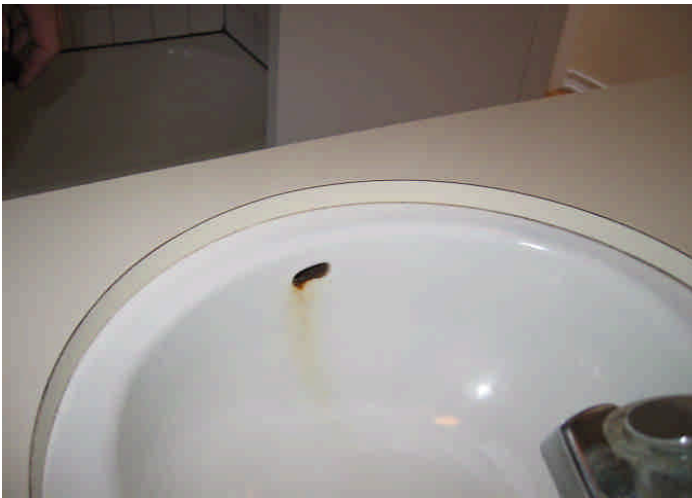
The bathroom sink is rusted, but functional.

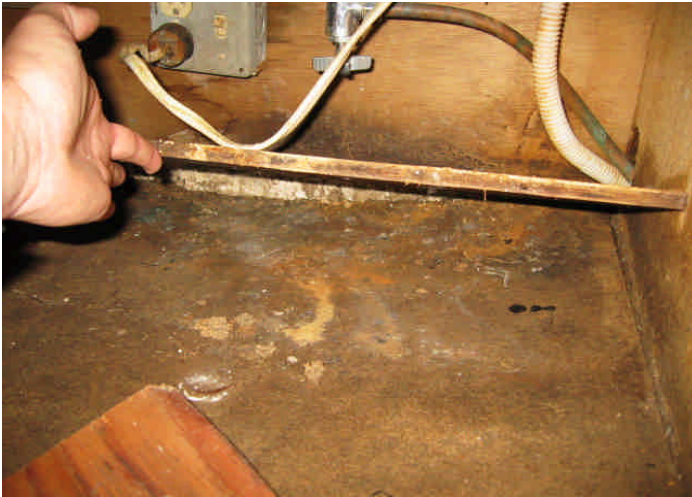
The floor and walls of the kitchen sink cabinet are moisture stained and/or damaged. No active leak was noted at the time of the inspection. There is no way to determine if there is any damage under the cabinet floor without removing it.

Recommend further evaluation of the area under the cabinet floor by invasive means.

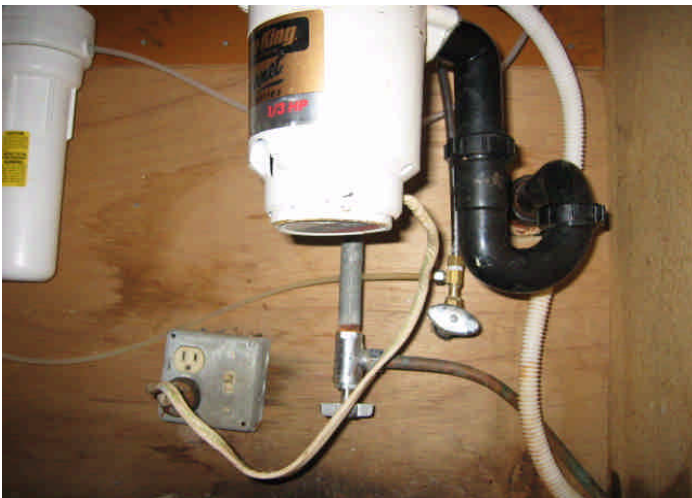
[Health & Safety] The electrical connection to the garbage disposal has been made with romex which is incorrect. The disposal unit should be wired with an appliance cord.

Recommend an appliance technician or electrical contractor evaluate and repair.

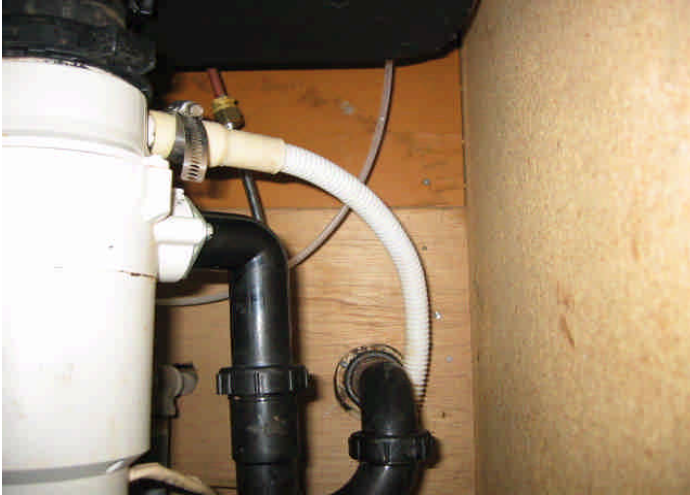
The dishwasher is not equipped with a mandated anti-siphon valve and discharges directly into the drain lines or garbage disposal unit, which is contrary to the installation instructions, and which also creates a potential drainage problem and health hazard.

Recommend plumber further evaluate.

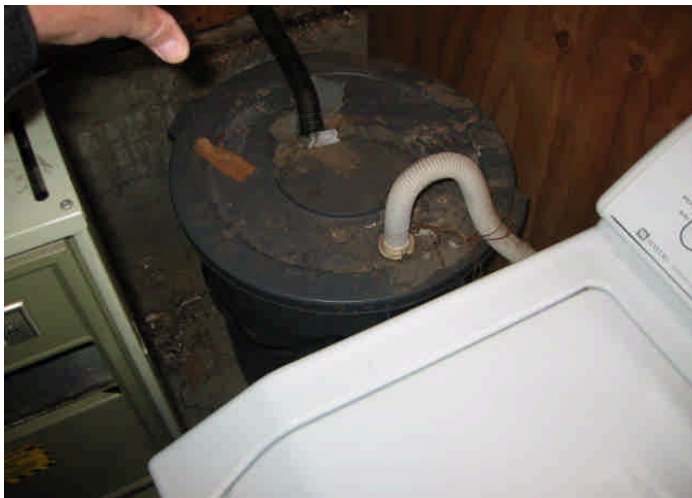
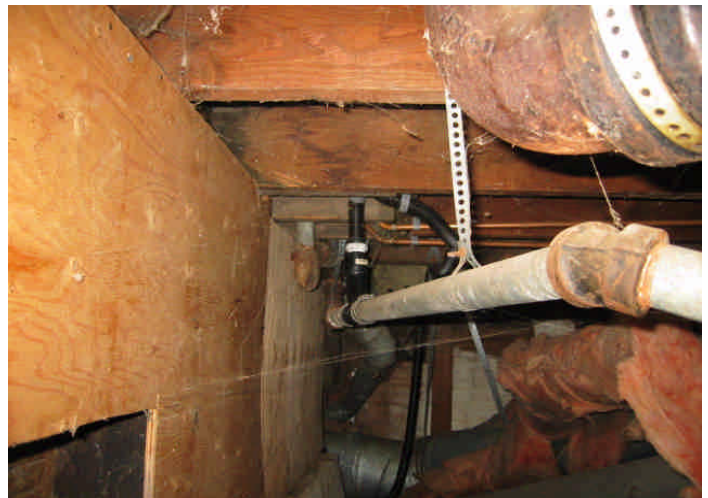
The washing machine discharges into a home made sump, which does not meet any modern building standards. Also the flexible discharge pipe terminates incorrectly into the main drain line. Recommend further evaluation by a plumbing contractor.
